23 HOME INSPECTION

SAMPLE REPORT

# Home Inspection Report

Sample Home, Edmonton,  
AB

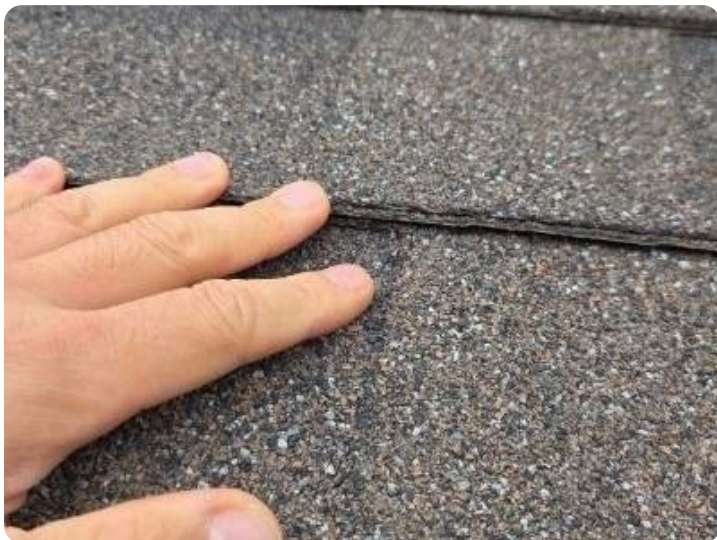
## 1.1 Raised fastener on the front side

Raised area at a fastener, front side

A fastener is pushing up at the front-side flashing.

A raised fastener can break the seal around it and let water in over time.

Re-secure and seal the fastener during routine roof maintenance.

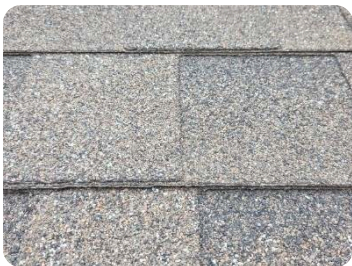
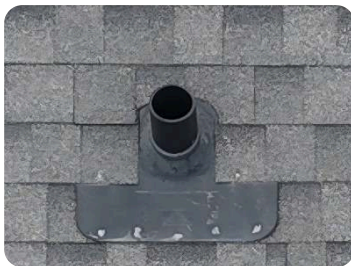
## 1.2 Shingles, vents and gutters in good condition

Asphalt shingles

Plumbing vent and flashing

The roof was checked from a ladder at the edge and by drone. The shingles, box vents, plumbing vent, flashings and valleys are in good condition. The gutters show minimal granule loss.

No action needed. Clean the gutters each autumn.

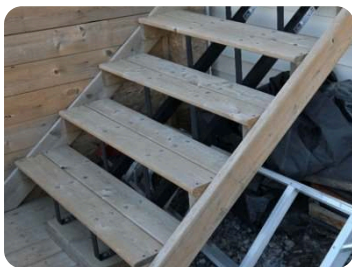
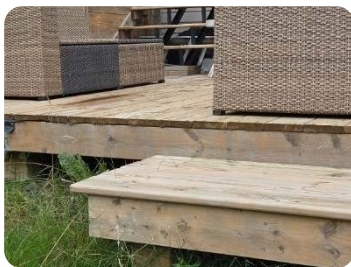
### 2.1 Deck and stairs have no railings

Deck stairs without a handrail

Deck without guards along its open side

The deck stairs have no handrail, and the deck has no guard along its open side.

Handrails and guards are standard safety features that help prevent falls.

Have a contractor install a handrail and guards. Check with the City whether a permit is needed.

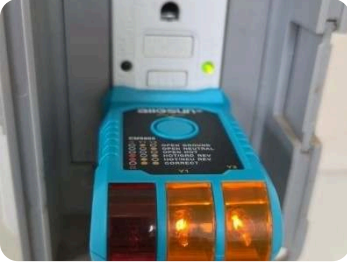
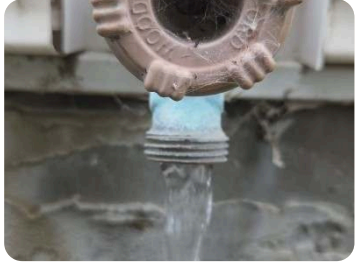
### 2.3 Siding, windows, doors and outlets

Exterior GFCI outlet tested

Hose bib working

The siding and stone veneer show only minor wear. Windows are in good condition, and the front door has minor cosmetic wear. The outside GFCI outlet and hose bib worked, and the vents are clear.

No action needed. Test the GFCI outlet monthly.

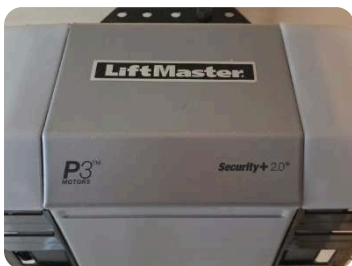
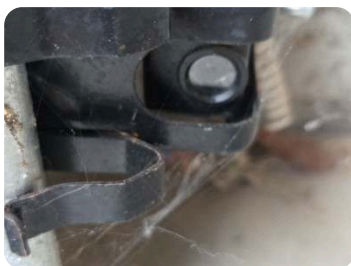
## Garage door and safety features working

Garage door opener

Photo-eye safety sensor

The opener, photo-eye sensors and auto-reverse were tested and worked. The weatherstripping is in good condition, and the wall to the house is sealed. The floor has typical hairline cracks.

No action needed. Test the auto-reverse once a month.

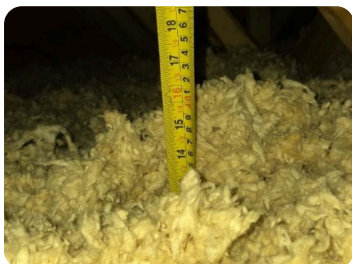
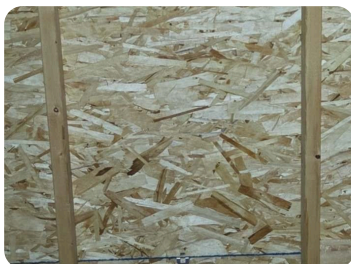
### 4.1 Insulation thin or disturbed in places

About 14 inches of insulation at the hatch

Roof sheathing, dry

The attic was viewed from the hatches. The insulation measured about 14 inches at the hatch, with some areas that look thin or disturbed. The roof sheathing is dry, and daylight at the soffit vents shows the attic is ventilated.

Thin spots let more heat escape, which can raise energy costs and add to ice dams in winter.

Have an insulation contractor level out the disturbed areas and top up any low spots.

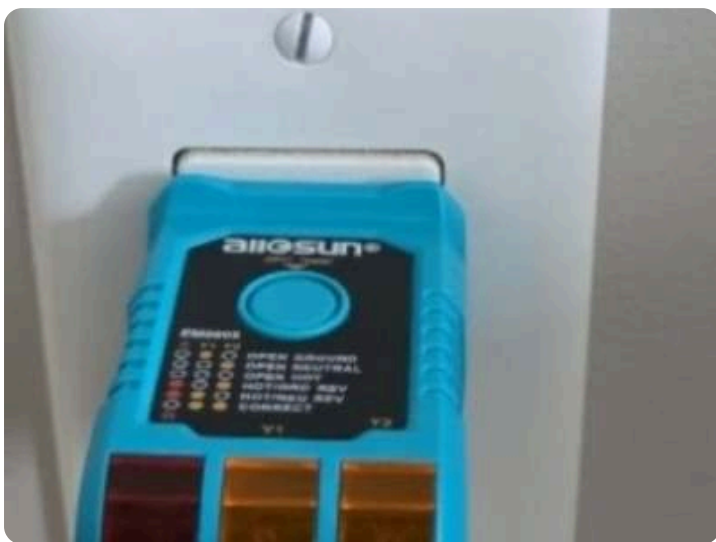
## 5.1 Bedroom outlet has no power

Outlet tester showing no power

One outlet in the primary bedroom had no power during testing.

It may be controlled by a wall switch or a tripped GFCI, or there may be a loose connection. The cause could not be confirmed.

Check for a wall switch or tripped GFCI first. If it still has no power, have a licensed electrician check it.

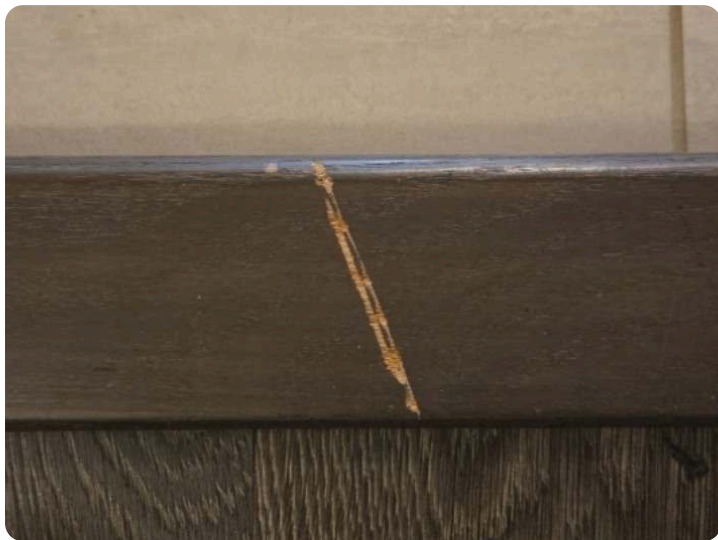
## 5.2 Scratched flooring near the stairs

Damage at the stair edge

The flooring and trim at the bottom of the stairs are deeply scratched.

This is cosmetic, but damaged edges can wear faster.

Repair or replace the damaged trim and flooring.

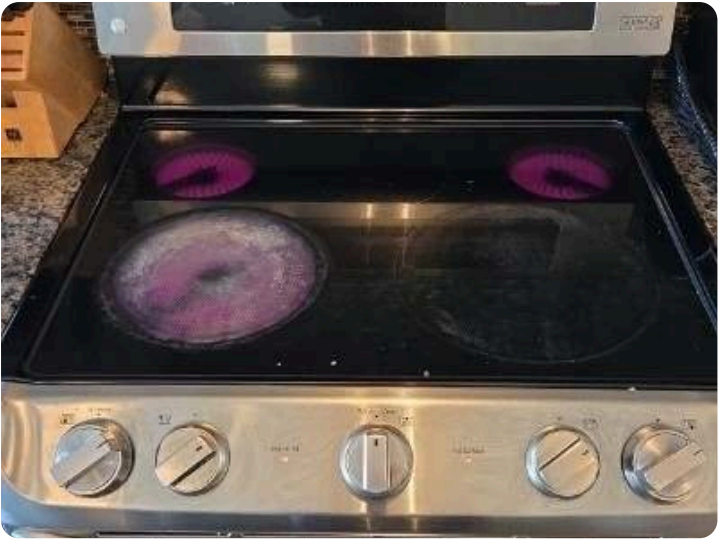
## 6.1 One range element does not heat

Range with elements turned on

One element on the right side of the cooktop did not heat when turned on. The other elements worked.

This is usually a failed element or switch.

Have an appliance technician repair it.

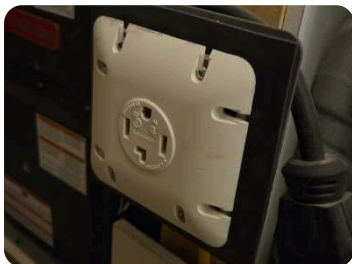
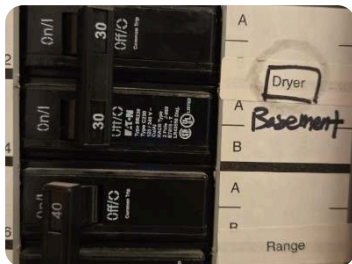
## 7.1 Dryer not powered, so not tested

Dryer unplugged at the outlet

Dryer breaker in the panel

The dryer was unplugged and its breaker was off, so it could not be tested. The washer was clean and worked.

The reason the dryer was shut off is not known. It could be simple, or it could point to an electrical or appliance issue.

Ask the seller why it was turned off. Have the dryer and its circuit checked before use.

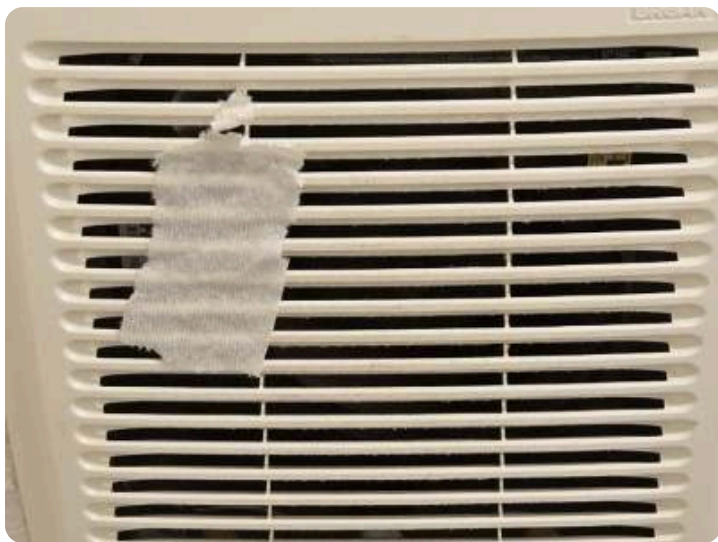
## 7.2 Dusty bathroom fan upstairs

Dust on the upper bathroom fan

The fan in an upper-floor bathroom has dust build-up. The other fans worked well.

Dust slows the airflow that removes moisture from the room.

Clean the fan cover and blades.

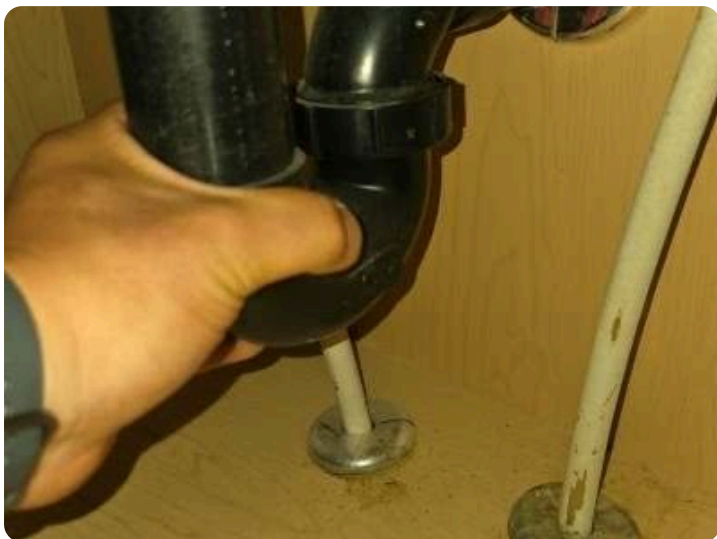
## 7.3 Fixtures, toilets and drains working

Dry drain trap under a sink

Each toilet was flushed three times and stayed stable with no leaks. Faucets and drains worked, the traps were dry, and the tub drained well. Bathroom GFCI outlets worked.

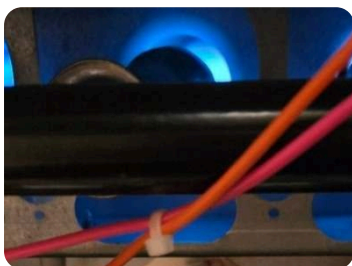
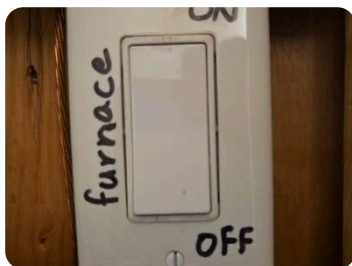
## 8.2 Furnace working, humidifier pad scaled

Steady blue burner flame

Furnace shut-off switch

The furnace is about 10 years old. It ran with a steady blue flame, the filter was clean, and the ducts are sound. The shut-off switch is in an easy-to-reach spot. The humidifier pad has mineral build-up.

A scaled pad works less well and can affect indoor air quality.

Replace the humidifier pad. Have the furnace serviced once a year.

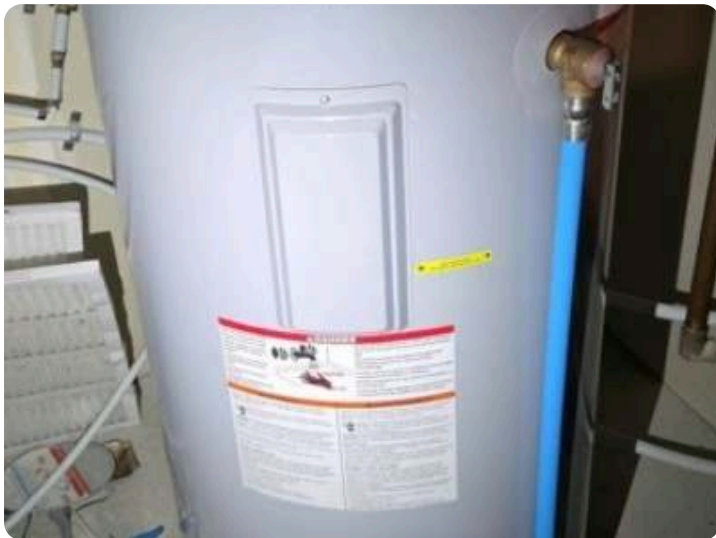
### **8.3 Water heater in good condition**

Electric water heater

The electric water heater is about 4 years old, with no sign of leaks. The pressure relief valve has a proper discharge pipe.

No action needed. Flush the tank once a year.
